COMPONENT INSPECTION ANALYSIS

00003485

Manufacturer: SAMSUNG ELECTRONICS INC

Part Number: KM4216C258G50

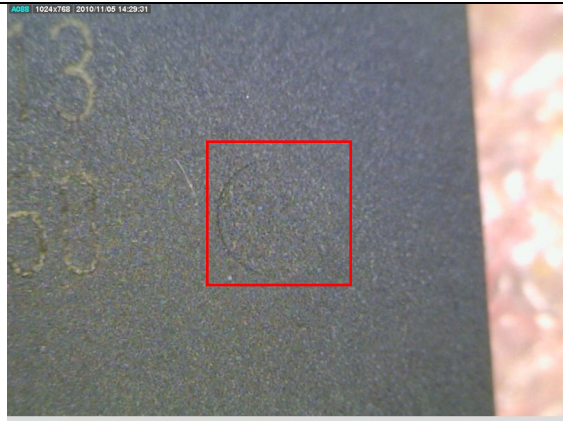
The top surface mold cavity is barely able to be seen and contains the same texture as the rest of the component surface.

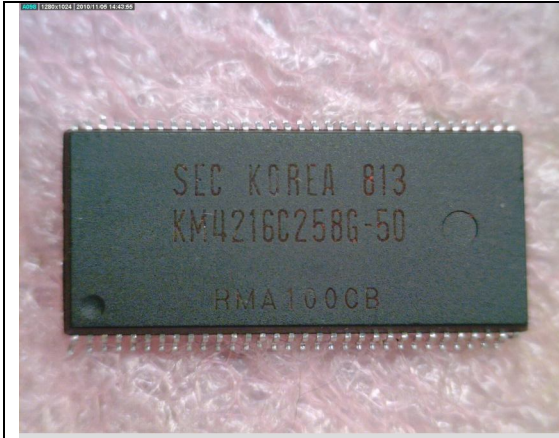
SAMPLE 2

The bottom surface mold cavities of this sample are not polished.

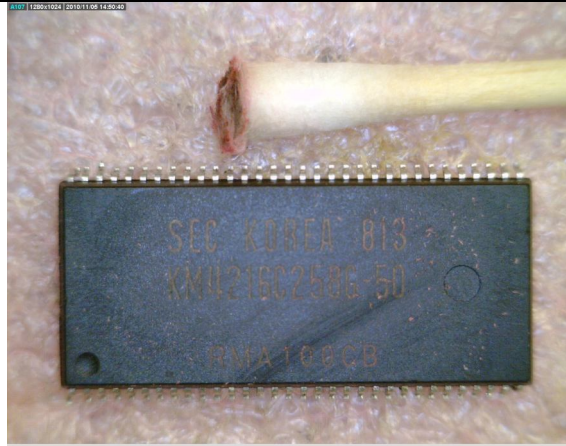
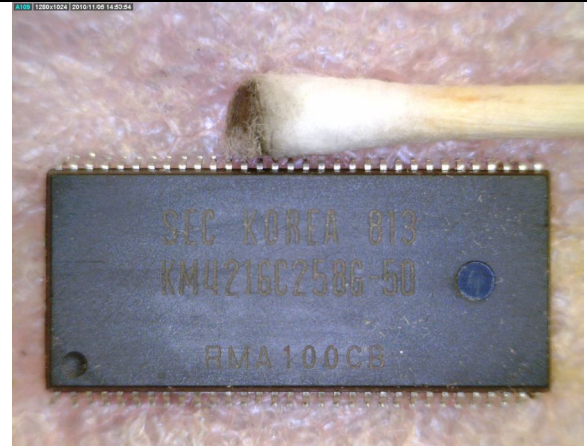
SAMPLE 2

Testing for marking permanency lifted a large amount of red color from the part markings.

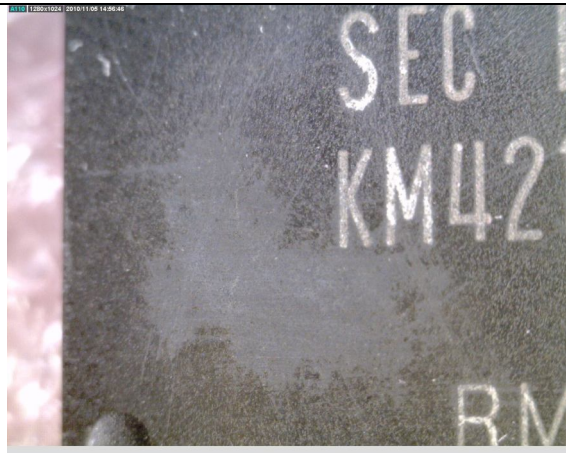
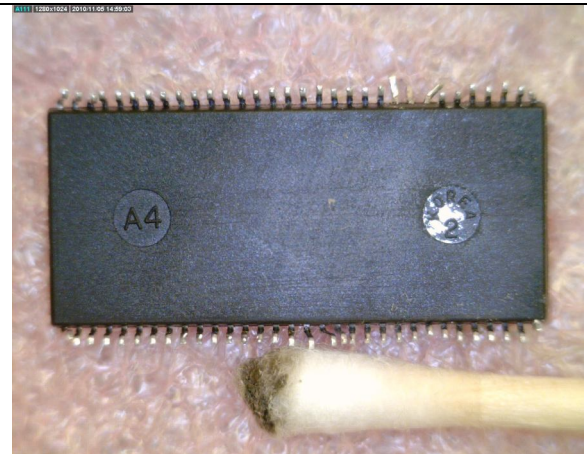
After vigorous wipe testing, the original surface can be seen beneath the blacktop coating. The bottom surface of this sample has also been blacktopped; the original polish of the country of origin dimple can be seen after much wipe testing.
